# HISTORIC AMERICAN ROOF TRUSSES

## II. Queenpost Trusses

# Historic Queenpost Truss Analysis

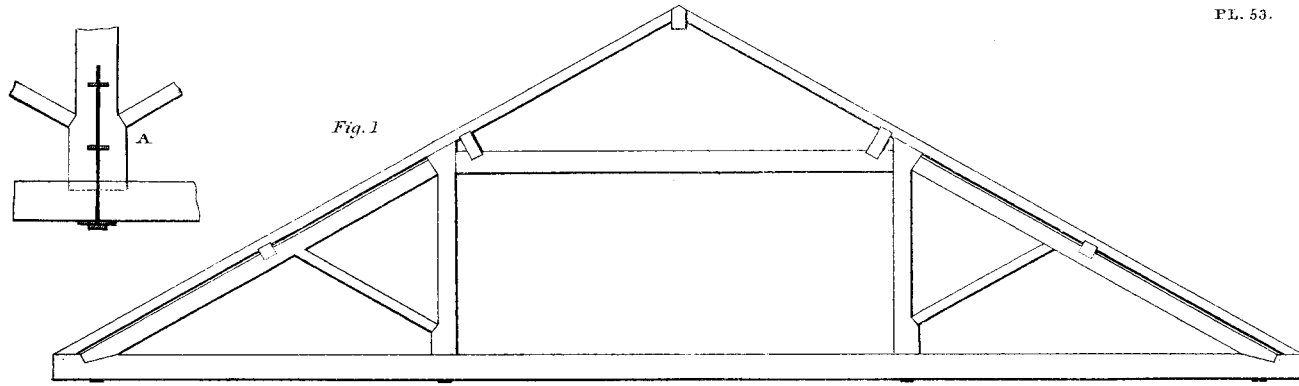
FIG. 1. QUEENPOST TRUSS BY 19TH-CENTURY AMERICAN ARCHITECT ASHER BENJAMIN. INSET SHOWS HIDDEN TENSION BOLT AT POST JOINTS.

... exhibits the design for a roof whose tie beam is intended to have 40 ft. bearing, but it may be extended to 45 ft. without increasing the size of the timbers. This example is provided with two queenposts instead of one kingpost. (Asher Benjamin, *Elements of Architecture*, 1843)

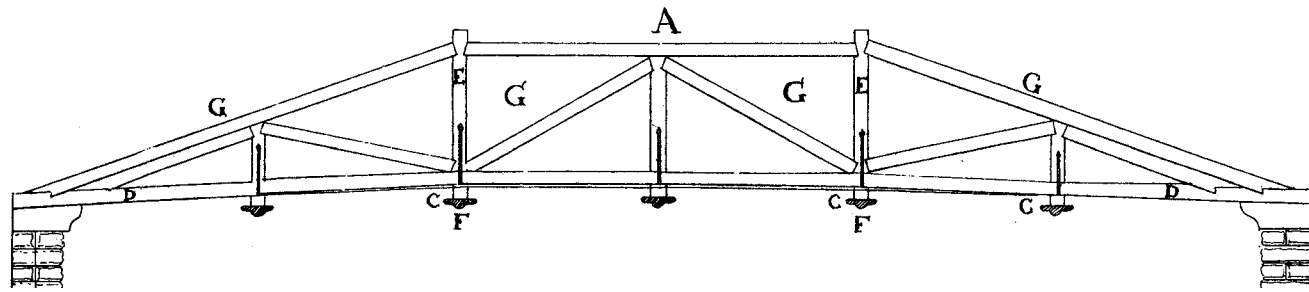
FIG. 2. QUEENPOST TRUSS OF THE BRIDGE AT CISMONE, SHOWN IN PALLADIO'S *FOUR BOOKS OF ARCHITECTURE* (1570).

Queenpost trusses with smaller, encased kingposts appear in what is probably the earliest illustration of the form, the bridge at Cismone shown in Palladio's *Four Books of Architecture* (1570). This same truss, sometimes with rods instead of posts (even Palladio's version has metal tension connections at the bottoms of all the posts), survives today in many historic wooden bridges and church attics throughout New England, with at least one 1881 bridge example in Elmira, Ont. This category of queen-dominated composite trusses presents clear load paths to the eye and to the experienced framer's intuition and uses no more material than is necessary to do the work (Fig. 2).

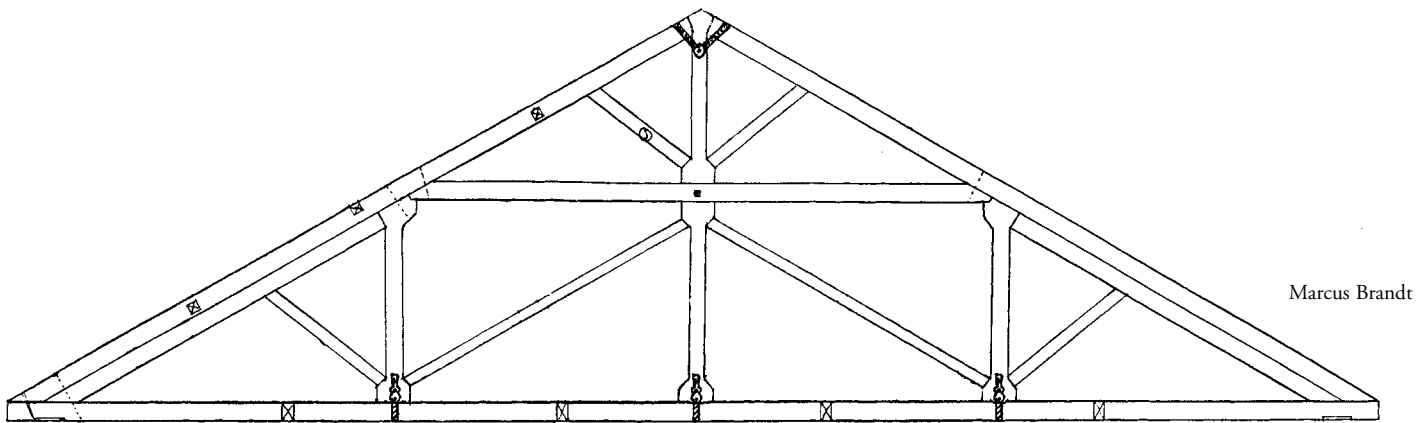
FIG. 3. PRINCIPAL TRUSS, CENTRAL MORAVIAN CHURCH, BETHLEHEM, PA., 1803, SPAN 60 FT.

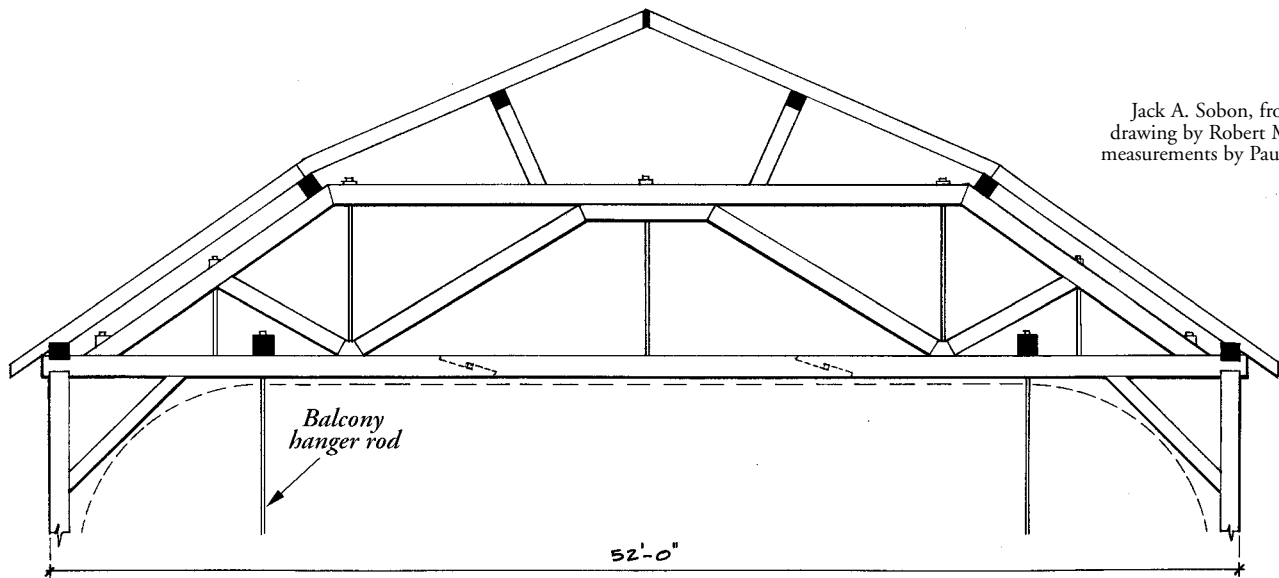
FIG. 4. COMPLEX ADAPTATION OF QUEENROD TRUSS, PIPER'S OPERA HOUSE, VIRGINIA CITY, NEVADA, 1883. NOTE SCARF JOINTS.

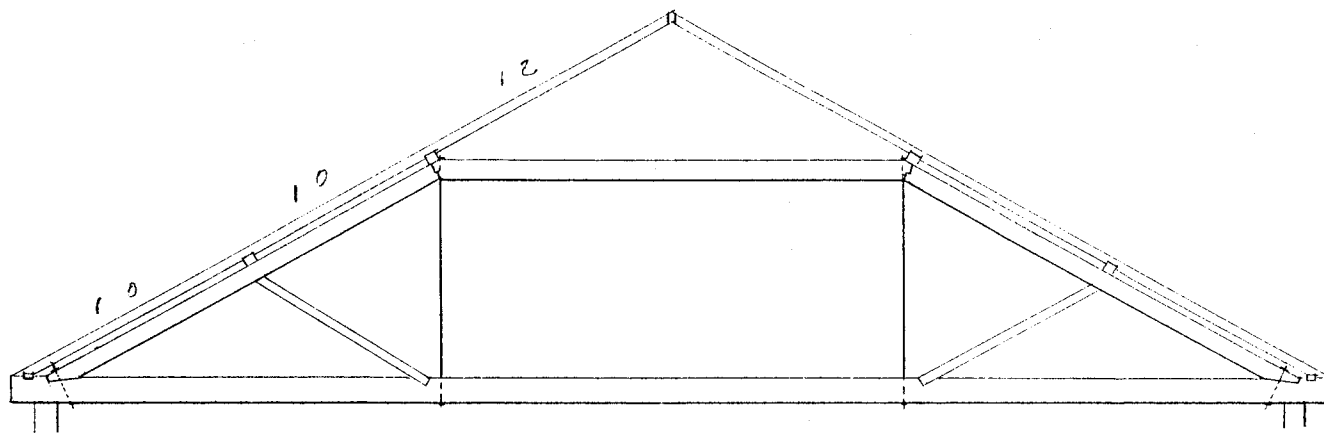
FIG. 5. QUEENROD TRUSS, 54 FT. SPAN, AT THE FIRST CHURCH OF BRIMFIELD, MASS., 1847,  
DRAWN BY THE CHURCH'S DESIGNER, CAPT. EDWARD LAMB, ARCHITECT.

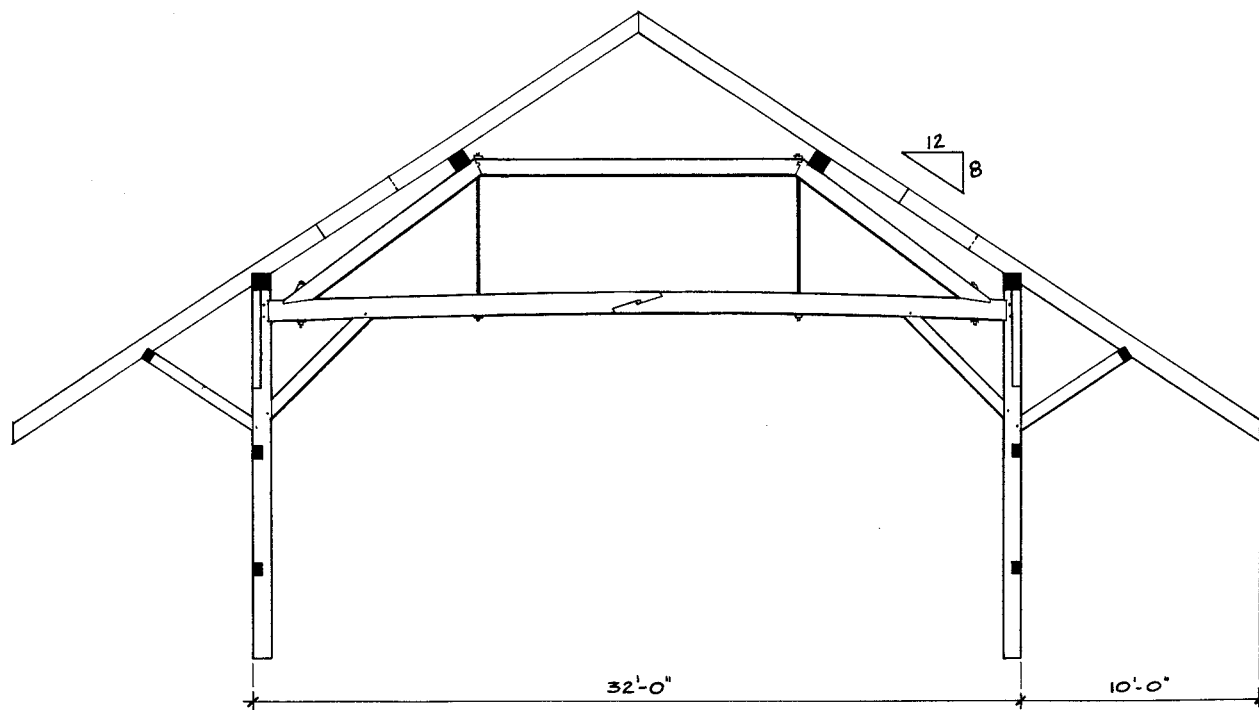
FIG. 6. QUEENROD TRUSS IN A 52X138-FT. RAILROAD FREIGHT SHED, VIRGINIA CITY, NEVADA, 1875. TRUSSES STAND ON 16-FT. CENTERS.

into the side of a wall post (Fig. 6). In this case, the 8x10 scarfed bottom chord bears on a 1-in. shoulder as well. Since neither ceiling nor floor is carried on this bottom chord, the 24-in. stop-splayed tabled and wedged scarf doesn't suffer significant bending. Knee braces rising from the post also add support against shear and reduce the overall span. The 1-in. iron rods nutted with ogee washers drop from the junction of the main brace and straining beam to support the bottom chord about 9 ft. out from the posts on each end. Trusses stand 16 ft. on center in this 138-ft.-long building. No timber is longer than 18 ft.

The angle between main brace and straining beam is mitred with a small integral tenon to keep the members in line. The main braces dap 3 in. into a bearing shoulder in the bottom chord where they are fastened by a 1-in. bolt. The ultimate bearing of the brace is 6 in. from the face of the post. A projected line of the main brace's slope if carried through the tie beam would end up within the post before exiting the tie beam, suggesting that little bending or shear will occur.

The 2x8 freight shed rafters, lapped and spiked to form a 31-ft. length, are all commons supported on a purlin carried at the queenrod head and at the plate. They continue outboard to form a 10-ft. overhang supported by 4x6 bracing rising from the wall posts in approximate opposition to the interior braces that rise to

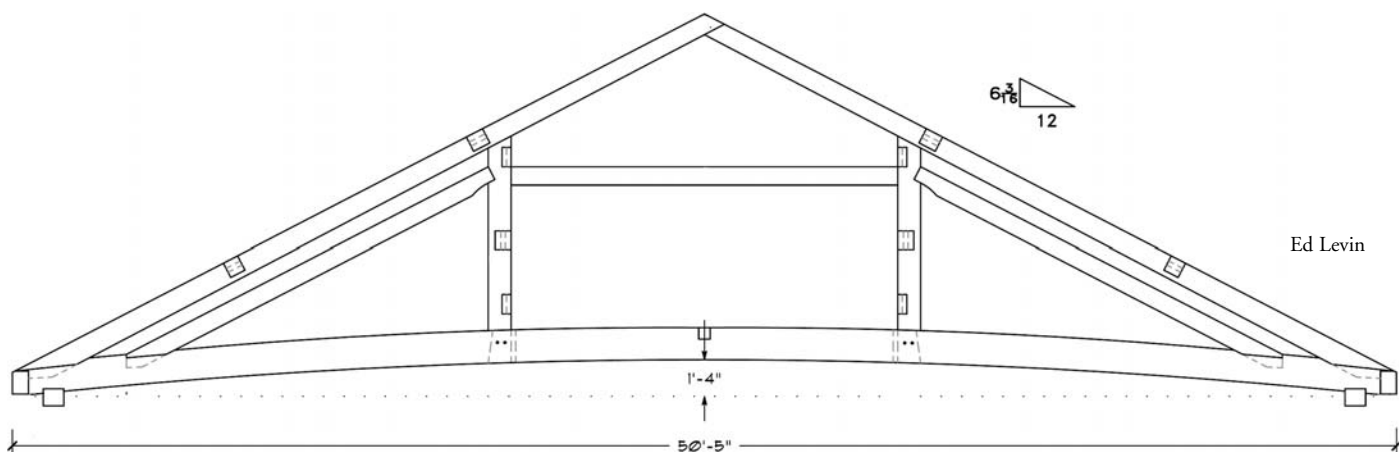
FIG. 7. QUEENPOST TRUSS AT CONGREGATIONAL CHURCH, PEACHAM, VT., 1806. TRUSSES ARE CAMBERED TO PRODUCE DOMED CEILING.

**Peacham Congregational Church, Peacham, Vt., 1806** (photo p. 20). The roof of this church rests on six queenpost trusses, 9 ft. on center, tightly joined and densely framed, 46 ft. 8 in. in the clear and 50 ft. 5 in. overall. The lower chords of the trusses are cambered progressively from the ends of the church toward the middle, in the pattern 8-14-17-16-14-8 in. of transverse rise, forming curvature in both directions and thus a shallow dome in the ceiling of the audience room below (Fig. 7).

The 7x10 queenposts taper slightly in all dimensions toward the top, and the 7x8 main braces and straining beams engage the queenposts with normal bearing, tenoned but without pins. Principal rafters 7x10 by 30 ft. sit on tenons at the heads of the queenposts, each affixed by a single 1-in. pin. The principal rafters are pinned in mortises at the extremity of the 11x14 bottom chord, bearing over the wall plate and extending to the eaves. The main braces of the truss are shouldered and tenoned (but again unpinned) into the bottom chord 23 in. from the inside of the plate. The queenposts, centered 15 ft. apart, support the bottom chord by means of the through-wedged half-dovetail joint, wedged

from above and with 1½ in. of taper on the dovetailed tenon. A pair of inline 1-in. pins also transfixes the dovetail 6 in. down from the top of the chord.

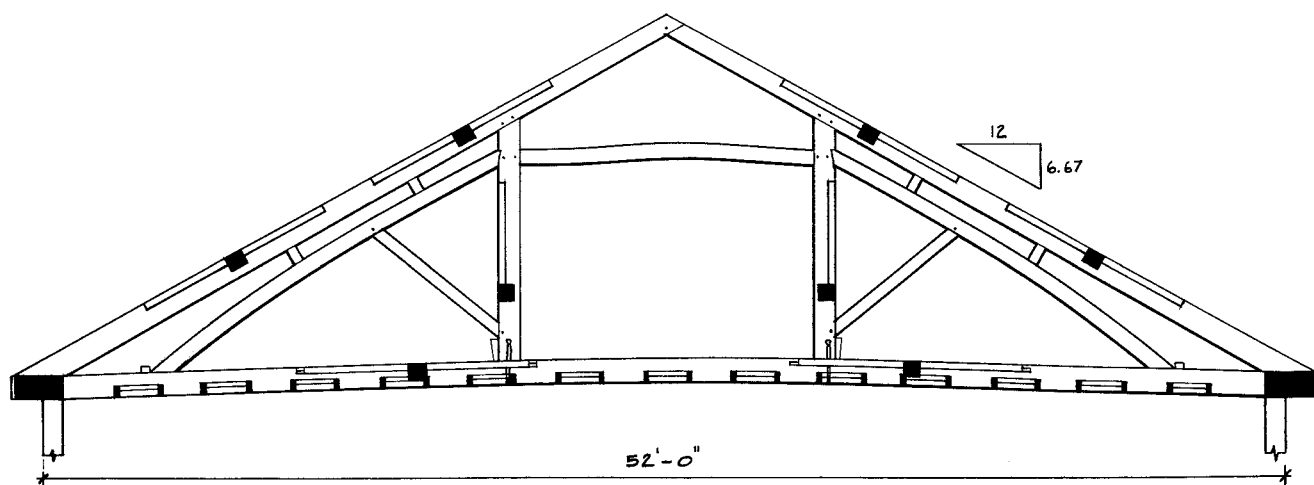
FIG. 8. EARLY-FORM QUEENPOST WITH CURVED OAK MAIN BRACES AND STRAINING BEAM AT MEETINGHOUSE, RINDGE, N.H., 1797.

Another probable reason for better than expected truss performance is that our codes and computer models posit loading harsher than the real world conditions experienced by the buildings. In Rindge (Fig. 8, p. 16), we note a pair of short struts joining principal rafter and main brace opposite a single strut carrying on from brace to queenpost, elements that help support point loads delivered by the purlins to the principal rafter. At Peacham (Fig. 7, p. 15), these struts are absent, and the principal rafters must handle substantial point loads from the lower purlins (estimated at 4500 lbs.) on their own, resulting in model deflections of up to 1.8 in. and bending stress up to 2300 psi in the spruce principals. You would expect the magnitude of these results to indicate a kink in the rafter, but apparently the Peacham principals never got this memo, and deflection is undetectable with the naked eye. Could we have overdone the model loading? I don't doubt the 65 psf ground snow, but we're talking about a tall church near the top of a hilltop village in a windy place, and for some time now the church has had a metal roof. The rules mandate conservative loading, but how much snow stays on these roofs?

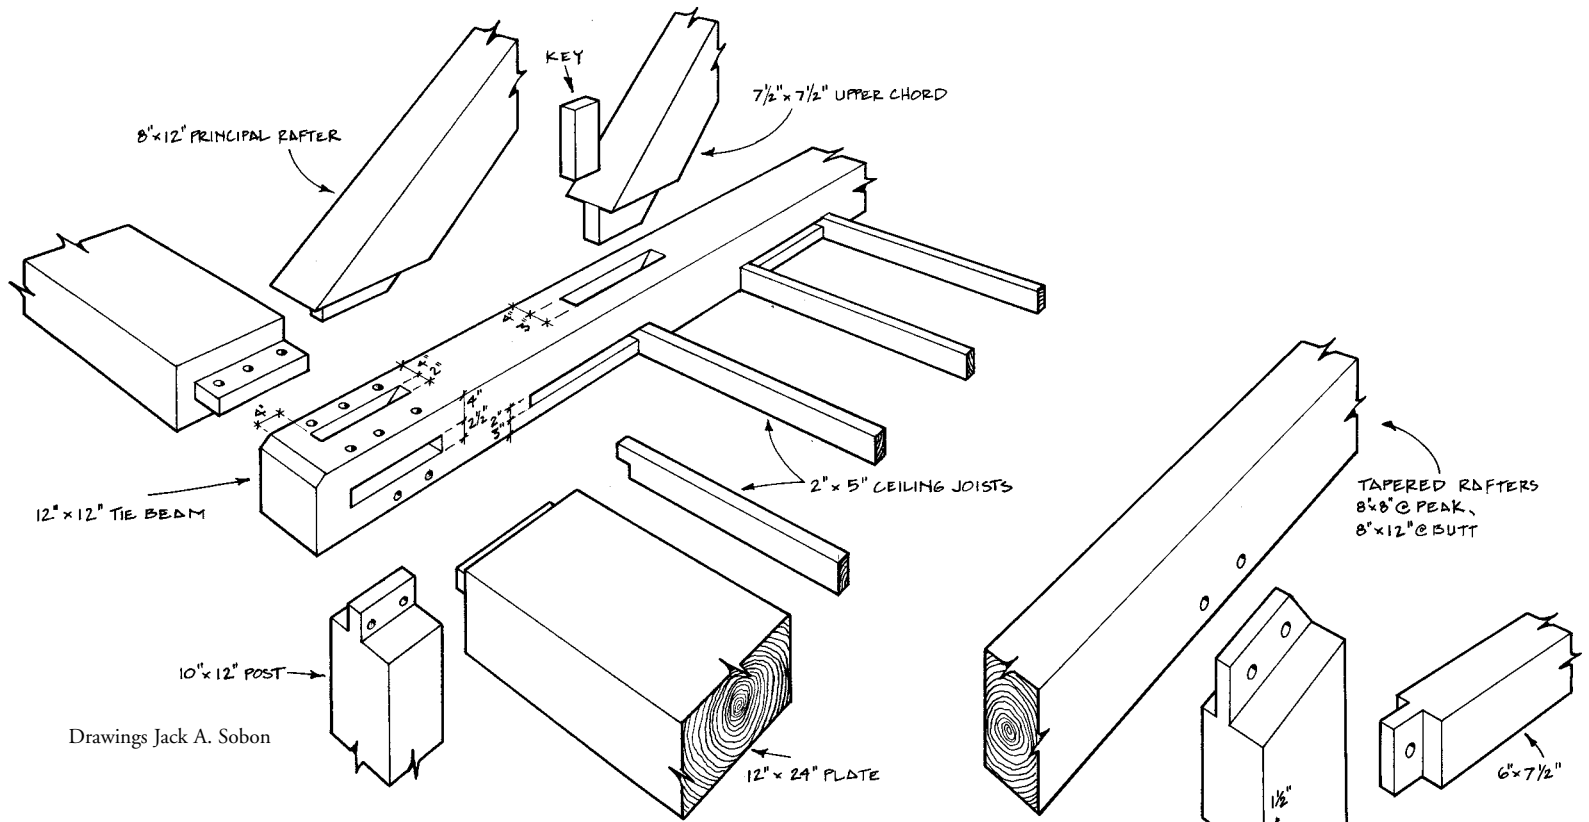
FIG. 9. AT RINDGE, PRINCIPAL RAFTERS AND END-WEDGED MAIN BRACES SEAT IN THE LOWER CHORD OF THE TRUSS.

The roof frame at Rindge is notable for both the size of some of its timbers (Fig. 9) and the tendency of almost all members to curve or taper in some dimension, giving it an especially dramatic pre-modern appearance. The wall posts are 28-ft. oak 10x12s and the tie beams atop them are 55-ft. white pine timbers, tapered from 12x14 to 12x12 and cambered between 14 and 25 in. to produce a shallow dome, as is found later at Peacham. The camber is so great in the ties that the framer had to use a system of 3-ft. marks rather than the usual 2-ft. marks to scribe the queenpost to the tie beam marks.

At the foot of the oak main braces is a 3-in. tenon, end wedged. The wedge facilitates the assembly of these huge curved forms, and driving or changing the size of the wedge allows the framer to fine-tune the camber of the truss and guarantee that the main brace is the major bearing member. The principal rafters are mortised over

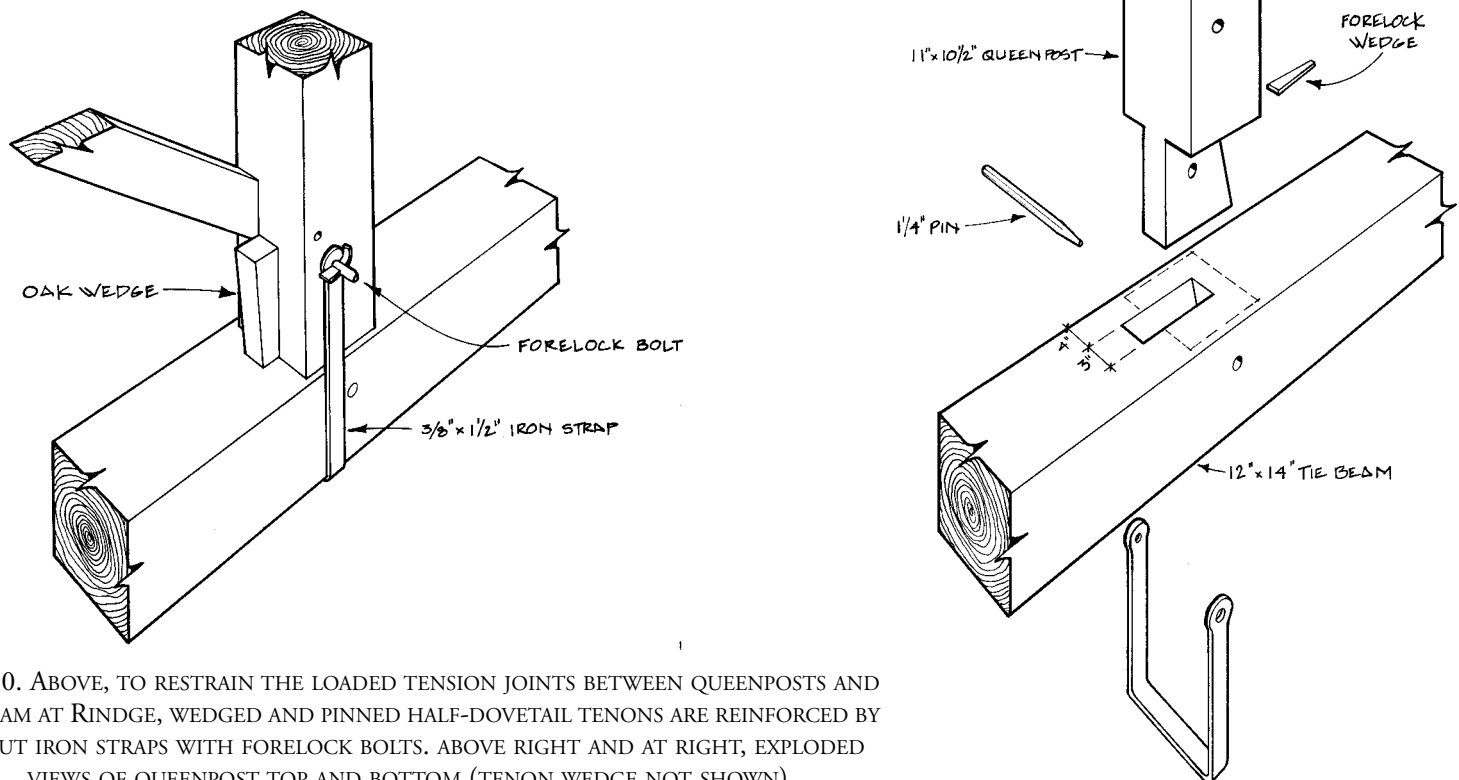
FIG. 10. ABOVE, TO RESTRAIN THE LOADED TENSION JOINTS BETWEEN QUEENPOSTS AND TIE BEAM AT RINDGE, WEDGED AND PINNED HALF-DOVETAIL TENONS ARE REINFORCED BY STOUT IRON STRAPS WITH FORELOCK BOLTS. ABOVE RIGHT AND AT RIGHT, EXPLODED VIEWS OF QUEENPOST TOP AND BOTTOM (TENON WEDGE NOT SHOWN).

The joint between the queenpost and the tie beam uses a 3-in. through-wedged half-dovetail tenon with a reinforcing ¾x1½-in. U-strap with forelock bolt (Fig. 10). The iron appears original and was likely necessitated by the difficulty of pulling and holding the huge tie beams into the exact curve required by the dome, even if the ties started with some natural sweep and hewn camber. Bending to strike two points correctly (the queenposts) is much more demanding than pulling up a long tie beam to one kingpost at its center.

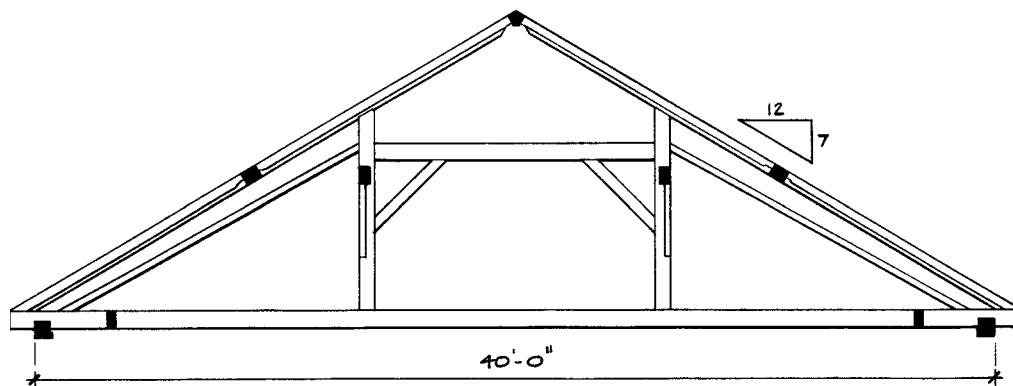
FIG. 11. COMMUNITY CHURCH, WATERBURY CENTER, VT., 1831, WITH NAÏVE KNEE BRACING AND UNDERSIZED MAIN BRACES.

The 9x10 bottom chord is 42 ft. long and laps and bears on an 8x8 plate. The 8x8 queenposts stand 14 ft. apart separated by an 8x9 straining beam, with 4x4 braces rising to it from the queenposts. While bracing of this sort is common in the so-called queenpost purlin systems of houses and barns, it is rare and unnecessary in trusses, where the compressive load of the roof system and the main braces of the truss itself, unsupported across a long span, are constantly forcing the heads of the queenposts inward and down, with little possibility of transverse racking. These unneeded braces may be the first clue that the framer did not understand how different the behavior of a truss was from a frame with intermediate posts. The main braces are the weak point of this truss: often waney, they are variously sized between 3, 4 and 5 in. thick by 7 in. deep. In service, they are all buckling along their 16 ft. length and compressing their inadequate end-grain sections into queenpost and bottom chord—all of this exacerbated by the low 7:12 roof pitch. Queenpost tenons enter the principal rafters above in greatly elongated mortises, removing the possibility of adding stability to the truss.

The unsupported purlin arrangement in Peacham is also found in Waterbury (Fig. 11, p. 18), but here the load effects predicted by the frame model are abundantly clear in the flesh. Here, truly, is the little roof that couldn't, a frame caught in the act of failure. So why does Peacham persevere while Waterbury comes to grief? In his discussion of Waterbury in the article just preceding, Jan Lewandoski pegs the villain by describing the church as "spanned by queenpost trusses of good material and joinery, but with disproportionately undersized main braces. . . a potentially fatal flaw."

Survive running the *NDS* math gantlet, and you find the 7x8 main braces in Peacham rated for a load of 25,500 lbs., which compares fairly well with the predicted load of 27,500 lbs. At Waterbury, on the other hand, the 7x3 main braces are limited by code to carry a mere 2,100 lbs. This against the 29,000-pound load estimate from the FEA model! Compared in terms of stress values, Peacham's main braces are rated to carry 455 psi (down from a tabulated  $F_c$  value of 900 psi) and Waterbury's to carry 100 psi (much reduced from the tabulated  $F_c$  of 800 psi)—while dealing with a whopping 1385 psi axial stress! So the Peacham main braces weigh in working at 108 percent of capacity, while at Waterbury they struggle to fill shoes 1385 percent too big. Put another way, the Waterbury main braces are undersized by a factor of 14.

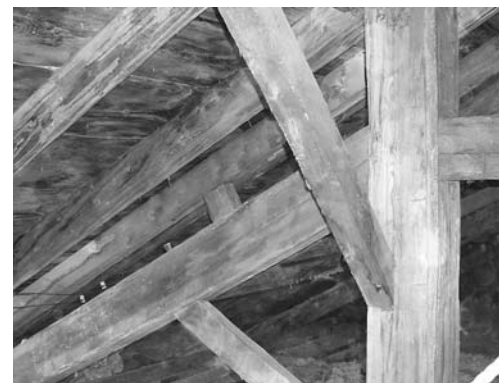
FIG. 12. DETAIL OF TOWER TRUSS, UNITED CHURCH, CRAFTSBURY, VT., 1816.

**The United Church of Craftsbury Common, Vt., 1816.** Like many other church roofs framed with kingpost trusses, Craftsbury's also employs one queenpost truss at the rear wall of the steeple, incorporating the tower posts (Fig. 12). These double-duty 10x10 posts, set about 9 ft. apart, are 20 ft. tall, with 22-ft. belfry posts rising from within them in telescoping fashion. An additional 33 ft. of spire and vane sit atop the belfry. Half of this collected load is carried by this queenpost truss. Main braces (8x9)

rise from mortised bearings on the bottom chords almost 2 ft. inboard from the wall posts and tenon into the queenposts, directly opposed by an 8x8 tower girt acting as a straining beam. The 6x6 principal rafters at this truss, rising at a slightly steeper pitch than the main braces, also tenon into the sides of the tower posts and contribute some support (Fig. 12, second rafter from left). There is no straining beam in a direct line with these principal rafters, but 4x5 hardwood braces descend to the straining beam below, where they are opposed by rising braces, and so provide some additional stiffness to the tower post. Unlike Waterbury Center, where the diagonal braces to the straining beam were superfluous, those at Craftsbury expand the effectiveness of the straining beam and, more important, help brace the tall steeple against racking movement.

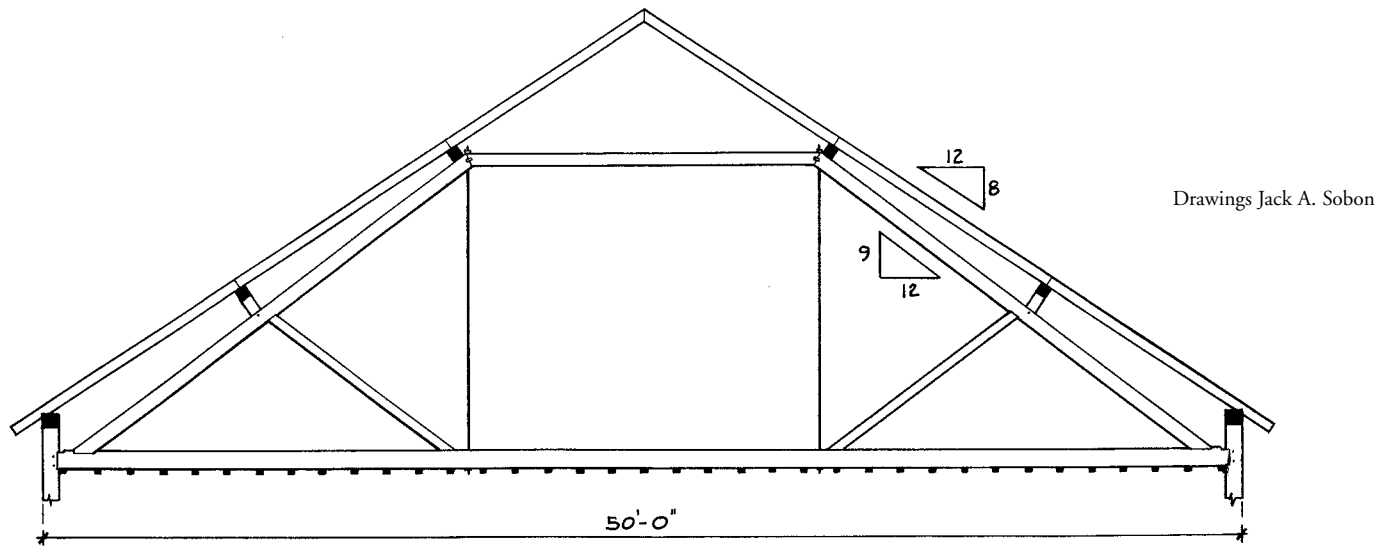
FIG. 13. LIGHT, SOPHISTICATED QUEENROD FRAMING AT THE COMMUNITY CHURCH, STOWE, VT., 1867.

The queenrod trusses supporting the roof and the ceiling of the audience room span 50 ft. (Fig. 13). They are lightly framed, with little mortise-and-tenon joinery, but they stand only 8 ft. apart and are performing well today. Other examples of queenrod framing are common from this period and even earlier, as in the 1847 Brimfield, Mass., Congregational Church (Fig. 5), where queenrod trusses with minor struts rising from the tie beam to the main braces span 54 ft.

The bottom chords of the Stowe trusses do not bear on a plate or post but (like the 1875 Nevada freight shed we saw earlier) instead use shouldered tenons to engage the wall posts about 1 ft. below the plate. The 9:12-pitch main braces sit in a 1½-in.-deep housing on the bottom chord, about 6 in. in from the post (Fig. 14). Instead of a tenon, a ⅝-in. bolt secures the connection. The 8:12 pitch common rafters bear on the top surface of the plate. The 6x7 main braces meet the 6x6 straining beam in a mitred butt joint fitted with a small key to help keep the members aligned (Fig. 15). Iron rods drop through this junction and support the bottom

In contrast to Waterbury, consider the later, highly evolved queenrod truss at Stowe (Fig. 13, p. 19). Here the 6x6 and 6x7 upper chord members (main braces) seem dangerously light for their job. But both our structural analysis and the excellent condition of the frame belie this judgment. So well did the builders understand their business that load effects are the lowest of any of the frames we have studied. Maximum deflection is less than half an inch. Bending stress is close to zero, except for a jolt in the tie where the main braces land. Maximum tensile stress in the tie is 180 psi against a tabulated value of  $F_t = 700$  psi. Maximum compression in the main braces tops out at 499 psi (tabulated  $F_c = 800$  psi, calculated allowable  $F_c' = 577$  psi, and maximum straining beam compression is 320 psi vs. tabulated  $F_c$  of 800 psi and calculated  $F_c'$  of 389 psi. In sum, under the biggest load we can throw at it, the Stowe truss operates at 25 percent of capacity in tension and 82 percent to 85 percent capacity in compression, and does so using 55 percent of the volume of material employed at Peacham and 65 percent of the total used in Rindge (material percentages adjusted for truss spacing).

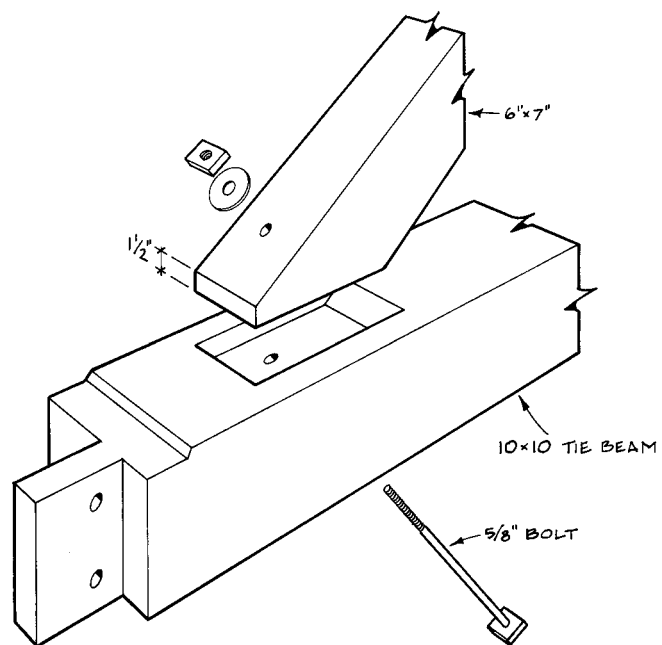
FIG. 14. MAIN BRACE FOOT IS DAPPED AND BOLTED TO THE TIE BEAM.

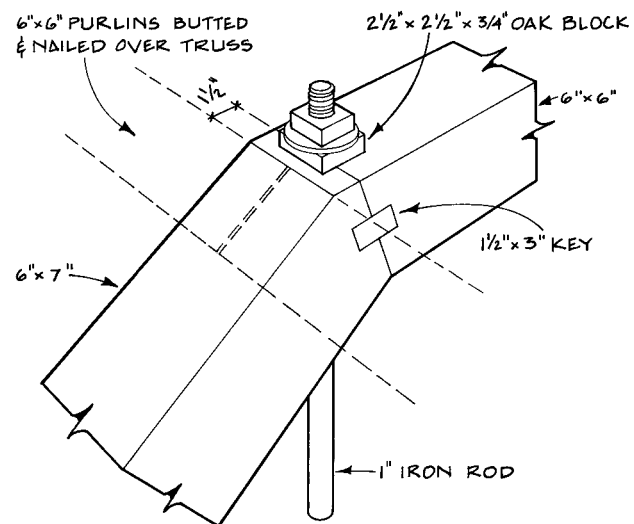
FIG. 15. MAIN BRACE IS BUTTED AND KEYPED TO STRAINING BEAM.

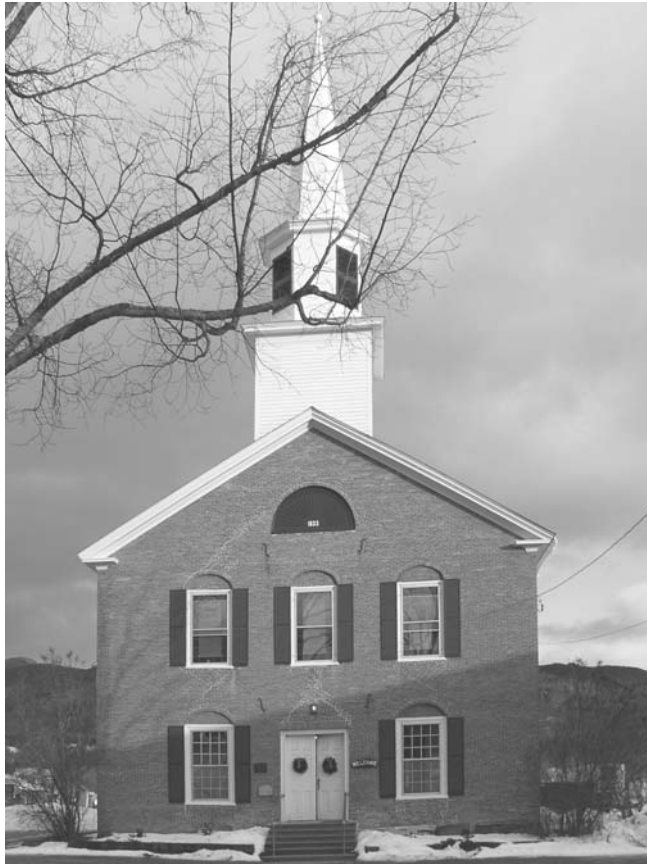
*Community Church, Waterbury Ctr., Vt., 1856.*

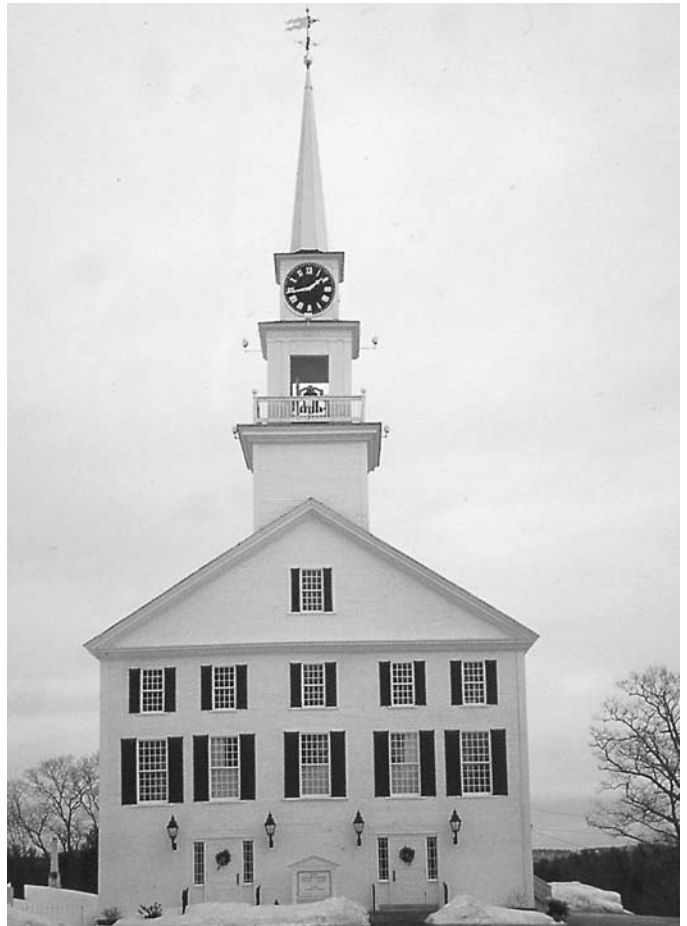
*Meetinghouse, Rindge, N.H., 1797.*

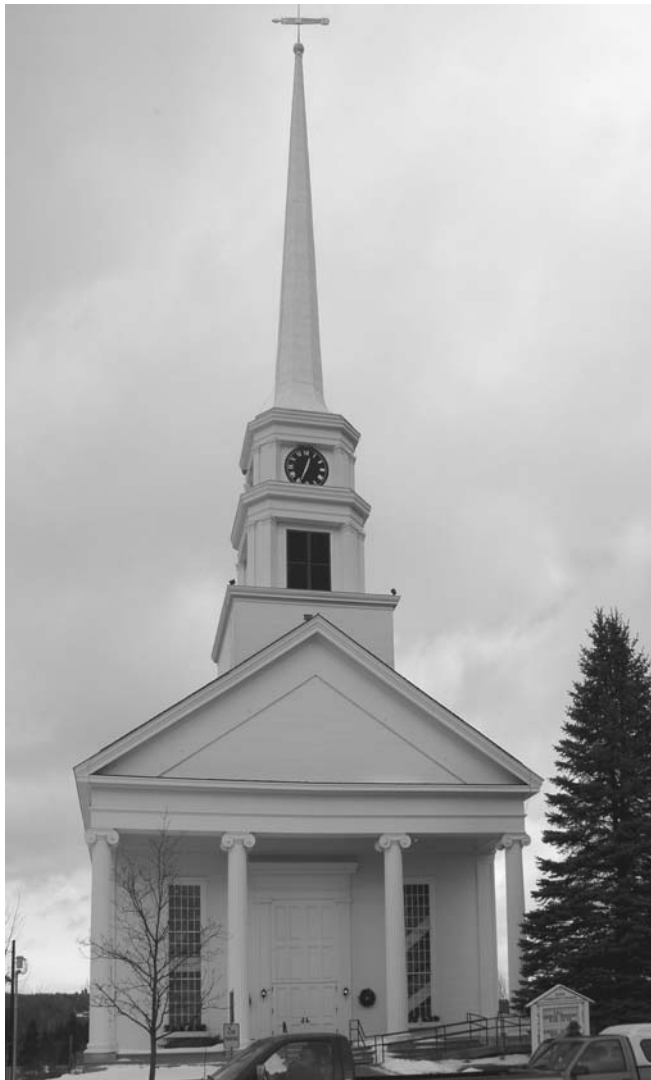
*Community Church, Stowe, Vt., 1867.*

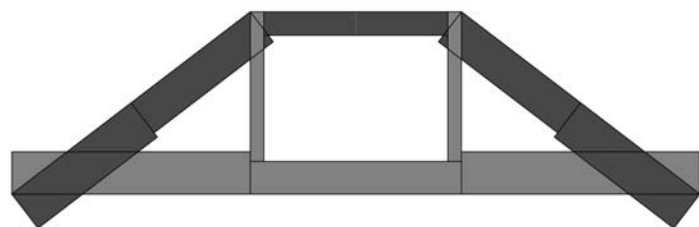
The essential core of the queenpost truss is a trapezoid founded on a long tie beam or bottom chord. In the force diagram above, darker shading indicates compression and lighter shading tension. Sloping inward and upward from the tie beam spring two main braces that rise to meet paired queenposts held apart by a horizontal straining beam. (In the case of queenrod trusses, the main braces meet the straining beam directly.) Load is applied by the

roof above and the floor or hung ceiling below, putting the composite upper chord (main braces and straining beam) into compression while the tie beam and queenposts are placed in tension. Earlier queenpost roof trusses, such as those at Peacham, Rindge and Waterbury (Figs. 7, 8, 11, pp. 15, 16, 18, respectively), complicate this structure by doubling the main braces with principal rafters above and, in the case of Rindge, by adding struts linking the more or less parallel inner and outer elements. The rafter-doubling strengthens the truss but also makes it more difficult to sort out the load path and quantify forces and stresses.
